SERVICE BULLETIN

Issue No: MG025

McMurdo SmartFind R5 GMDSS Radio IMO MSC. 1/Circ. 1460 Update procedure

Reason: Compliance with revised ITU Radio Regulations after 1st January 2017

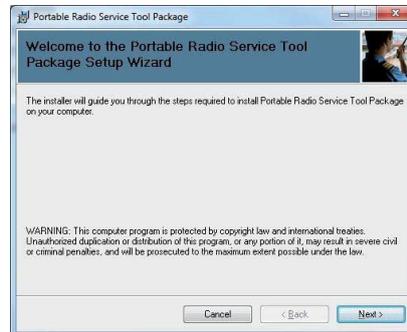
Figure 11 - Install wizard for the service tool.

The service software is installed on the service PC by using the downloaded **Portable Radio Service Tool Package**. Be sure the folder is un-zipped and stored locally on the service PC. Double click on the **setup.exe** icon from the un-zipped folder and follow the instructions, to update the system.

The installer program removes old installations before a new version is installed. Therefore, it is not recommended to store personal set-up files in the selected install directory. The software installation procedure should be executed whenever any upgrades are recommended.

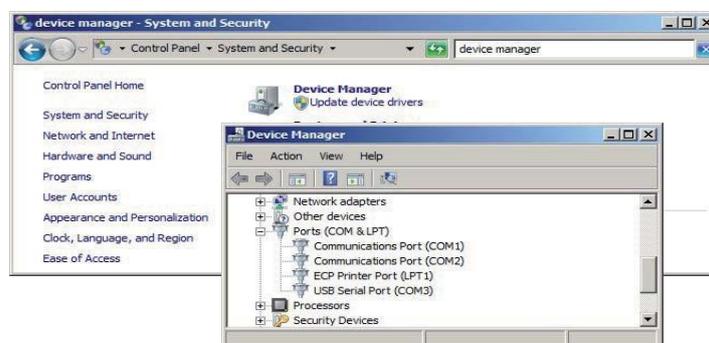
After installation, the service cable (USB end) is plugged into a free USB slot on the service PC. The PC should now be able to identify a new USB device.

The PC sets up a virtual COM port, which later is to be used by the Service Tool.

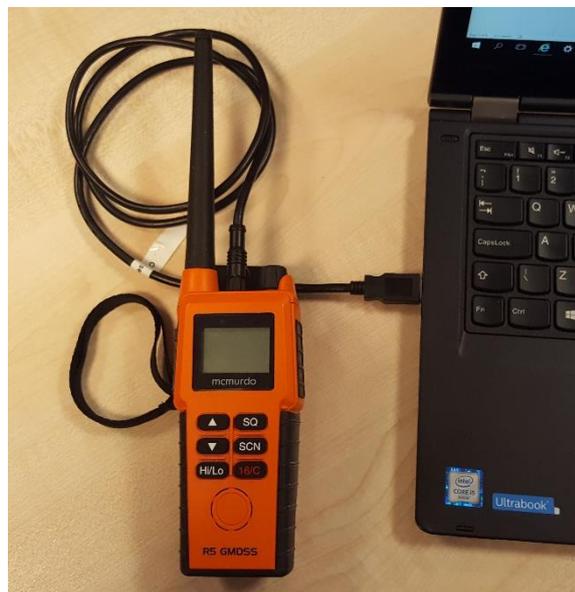
Figure 1 - Simple connection between service PC and radio.

The radio is connected to the service PC by first plugging the service cable (USB end) into a free USB slot on the service PC. Then screw the service cable onto the radio top connector, which – under normal conditions is used for attaching accessories.

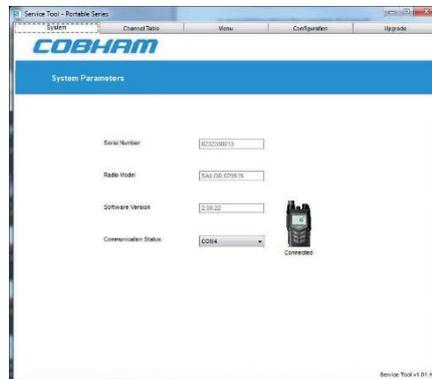
Figure 3 - Portable Radio Service Tool start-up screen.

The McMurdo SmartFind Radio Service Tool is initiated from the **Start** menu. Here it is also possible to bring up the manual. The tool can also be started by clicking on the SAILOR portable Radio Service Tool"-icon, located at the PC-desktop after installation. The startup window will appear on the service PC screen.

To access the radio, select the appropriate COM port through the Communication Status drop down on the user interface. When the correct COM port is selected on the start-up page (System tab) the fields on the start page will populate with the basic radio identity information (**Serial number**, **Radio model** and **Software version**) as read out from the radio.

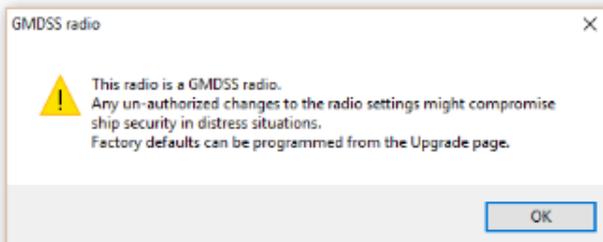
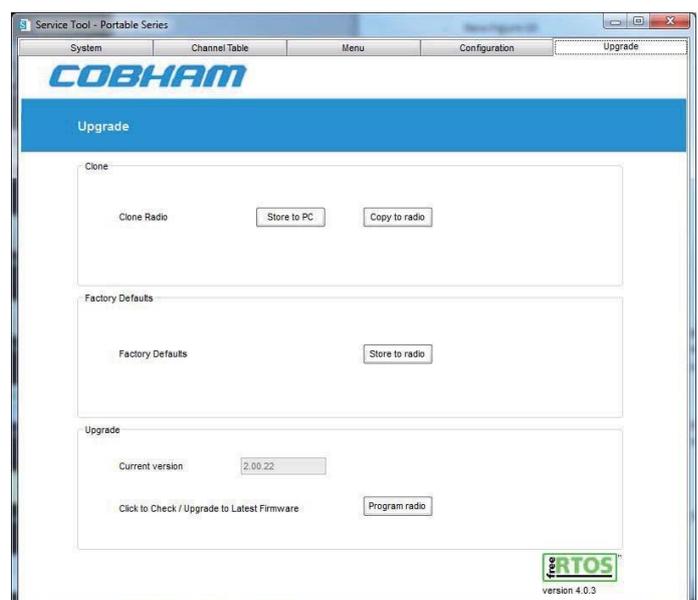
1. Click on the Upgrade Table – a caution window will come up, press ok.

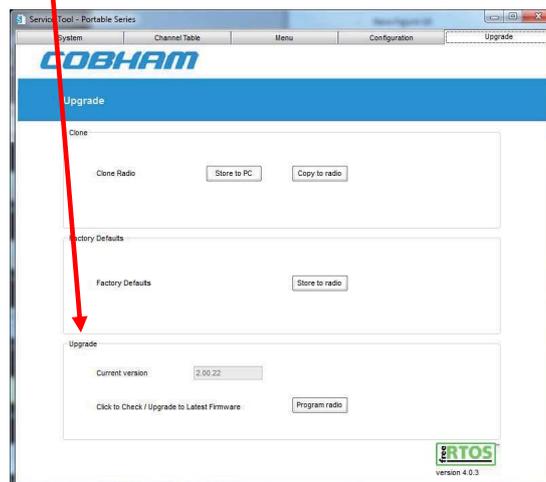
2. Find the Upgrade box on the Upgrade Page

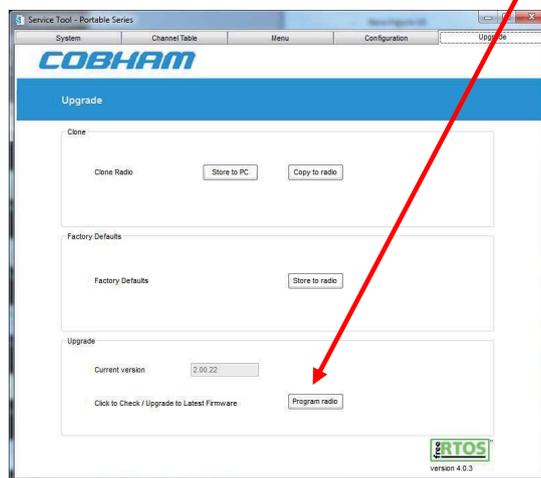
3. Click on the Program radio button when ready to program

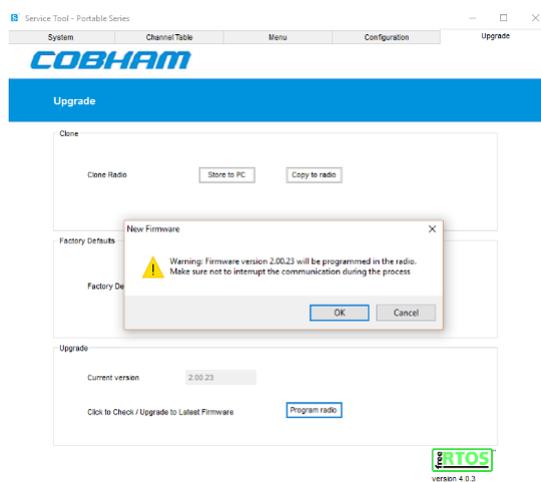
4. The following caution window will appear, press ok

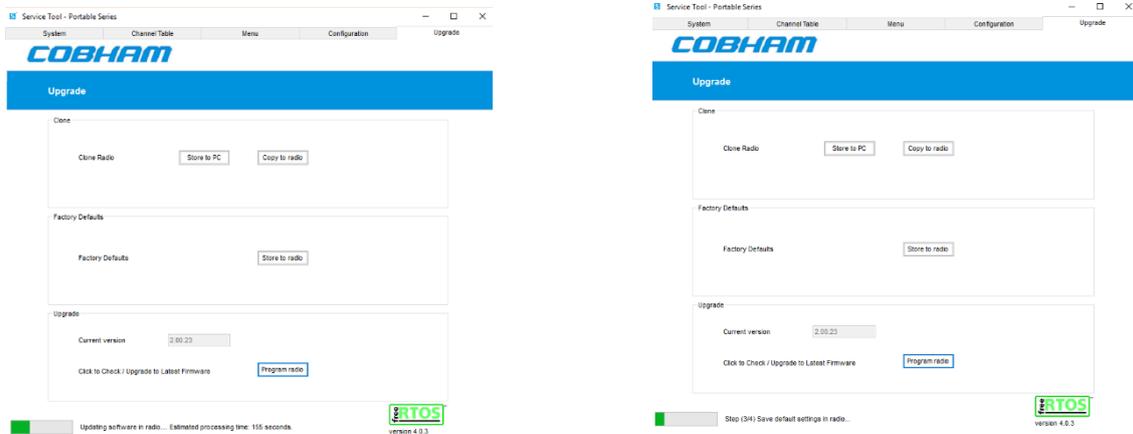
5. Two programming status pages will be shown with progress bars

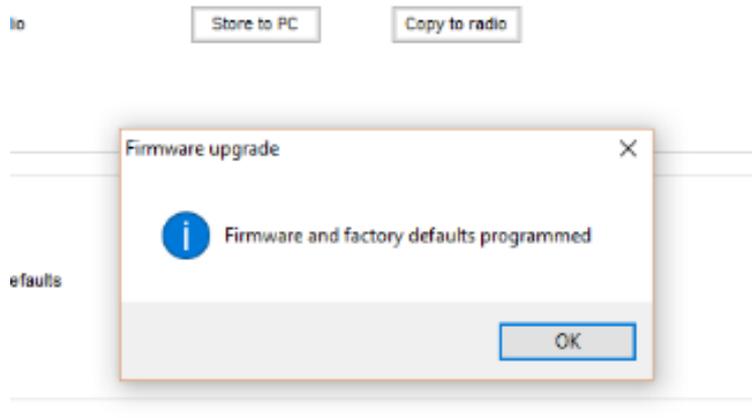
6. When update has been completed, the following window will shown
