### **Product Information** X -904 Offshore Personnel Transfer Device

X-904
Assembly Instructions

X-904 **Stretcher Procedures**

X-904 Inspections

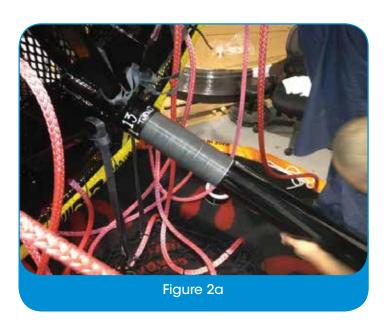
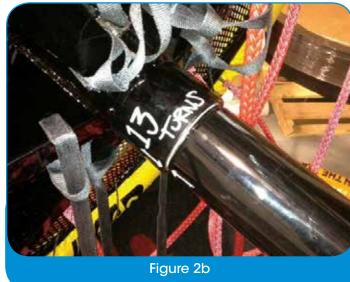
## Step #2 – Attach threaded pole to roof of basket

- 1. With crane: attach top of basket to crane hook and lift until grab lines become tight. Without crane: lay top of basket on side as shown in figure 2a.
- 2. Insert threaded pole and screw pole all the way until threads bottom out as shown in figure 2b.

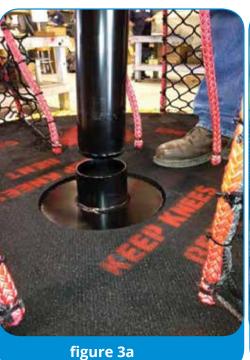
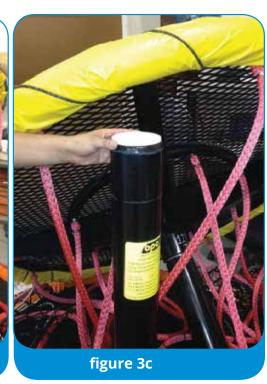
figure 3b

- 1. Insert bottom pole in receiver on bottom frame. figure 3a
- 2. Place coupling over bottom pole. Slide carefully down to the bottom of pole so as to not damage the coupling. **figure 3b**
- 3. Place Teflon bearing on top of bottom pole. **figure 3c**

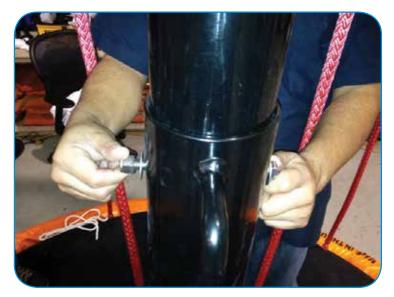
1. Join the top and bottom poles by lifting the top assembly and placing the top pole on the bottom pole with the Teflon bearing between them.

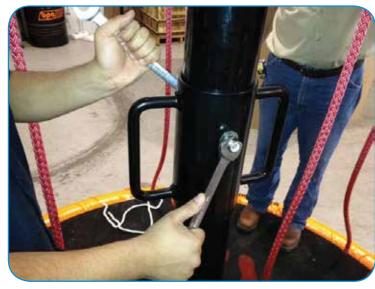
2. Slide coupling over pole seams and insert the supplied bolt, nut and washer.

3. Tighten bolt until snug. Do not over tighten.

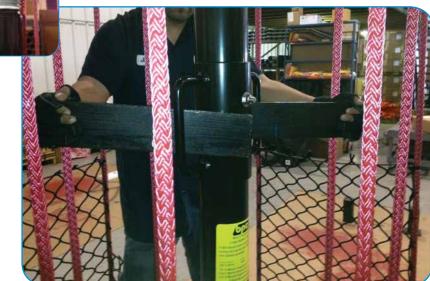
- 1. Starting by hand, twist the center pole counter clockwise until tight. Take note of the number of turns.
- 2. Finish tightening coupling with boards until prescribed number of turns is achieved as indicated on top of frame.

**Important note:** Your X-904 is shipped with "number of turns" markings. This number is set by Billy Pugh Company engineers during assembly and is required for proper torque and safe operation of the device.

number of turns = The number of "counter clockwise" turns the center pole needs to remove the grab line "slack" required during assembly.

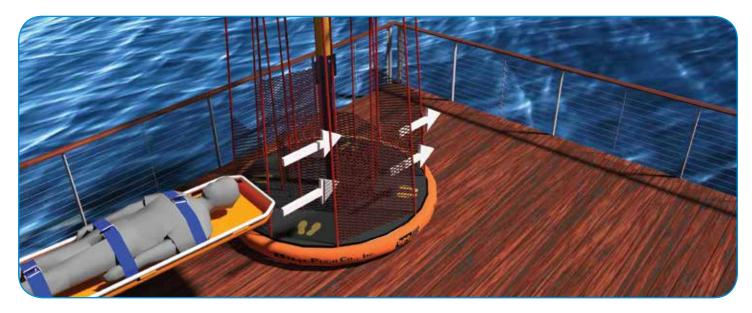
1. With X-904 in the working position, carry one end of the stretcher in through any opening and out through the adjacent opening. With the center of the stretcher inside the X-904, lower the stretcher to the floor.

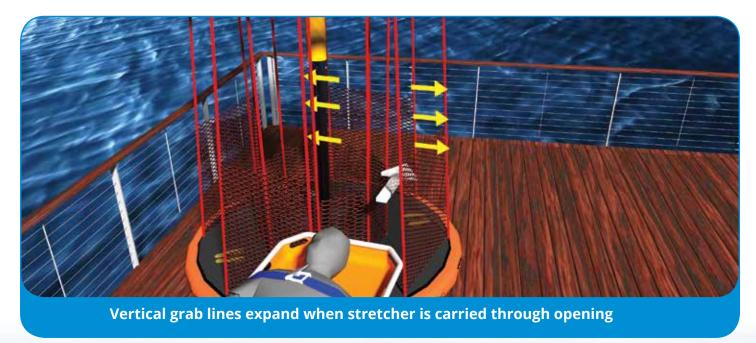
2. Vertical grab lines will expand to accommodate the width of the stretcher.

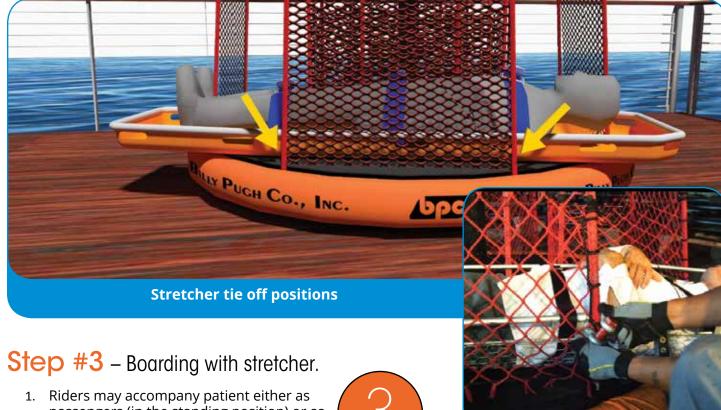
1. Tie off stretcher using the X-904's outer vertical grab lines.

Riders may accompany patient either as passengers (in the standing position) or as attendants (in the kneeling position).

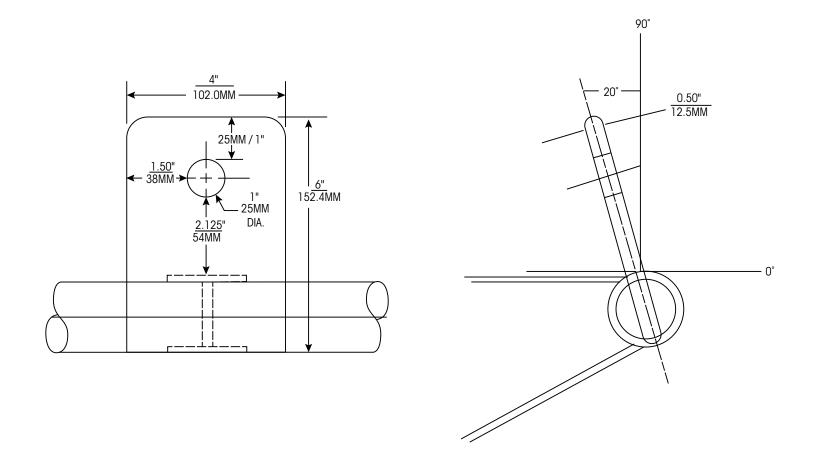
900 SERIES TRANSFER NET PAD EYES SPECIFICATIONS

| Inspect top and bottom of powder coated aluminum frame including top and bottom ring, expanded metal top and center pole. Look for excessive wear, cracks, or corrosion. | | |
|--|---|--|
| Inspect the pad eyes on the upper ring of the X-904. There should be no cracks or damage to the welds. The hole in the pad eye should still be round and not elongated by more than 5%. The angle of the pad eye from the upper ring should be 20 degrees inside of vertical (see drawing). Some wear of the coating is expected and acceptable but there should not be excessive wear of metal. | | |
